**SAHEL AND WEST AFRICA PROGRAMME IN SUPPORT OF THE GREAT
GREEN WALL INITIATIVE**

NIGERIA EROSION AND WATERSHED MANAGEMENT PROJECT (NEWMAP)

**IUCN/MEDIA WORKSHOP
LOME TOGO**

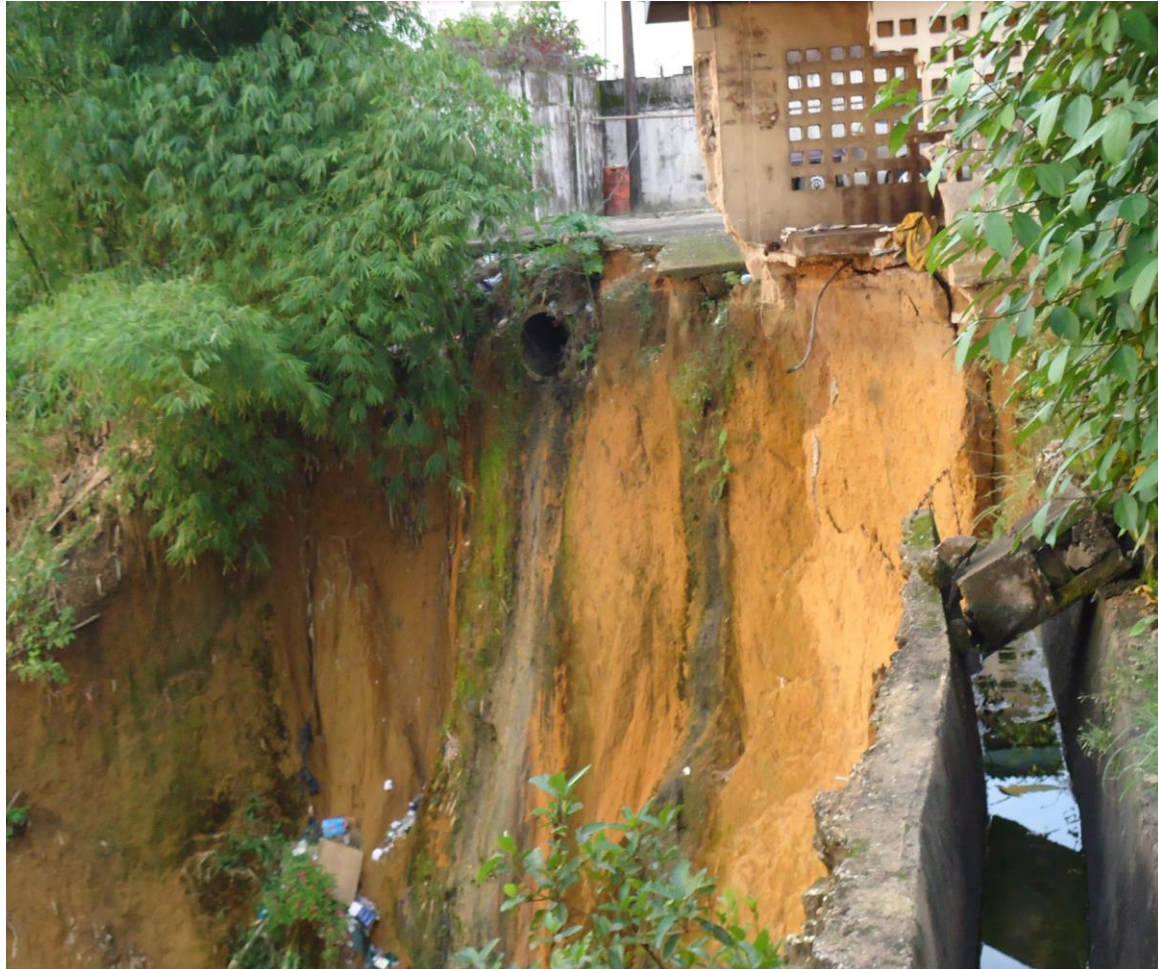
Atakpa before

Atakpa Erosion site CrossRiver State

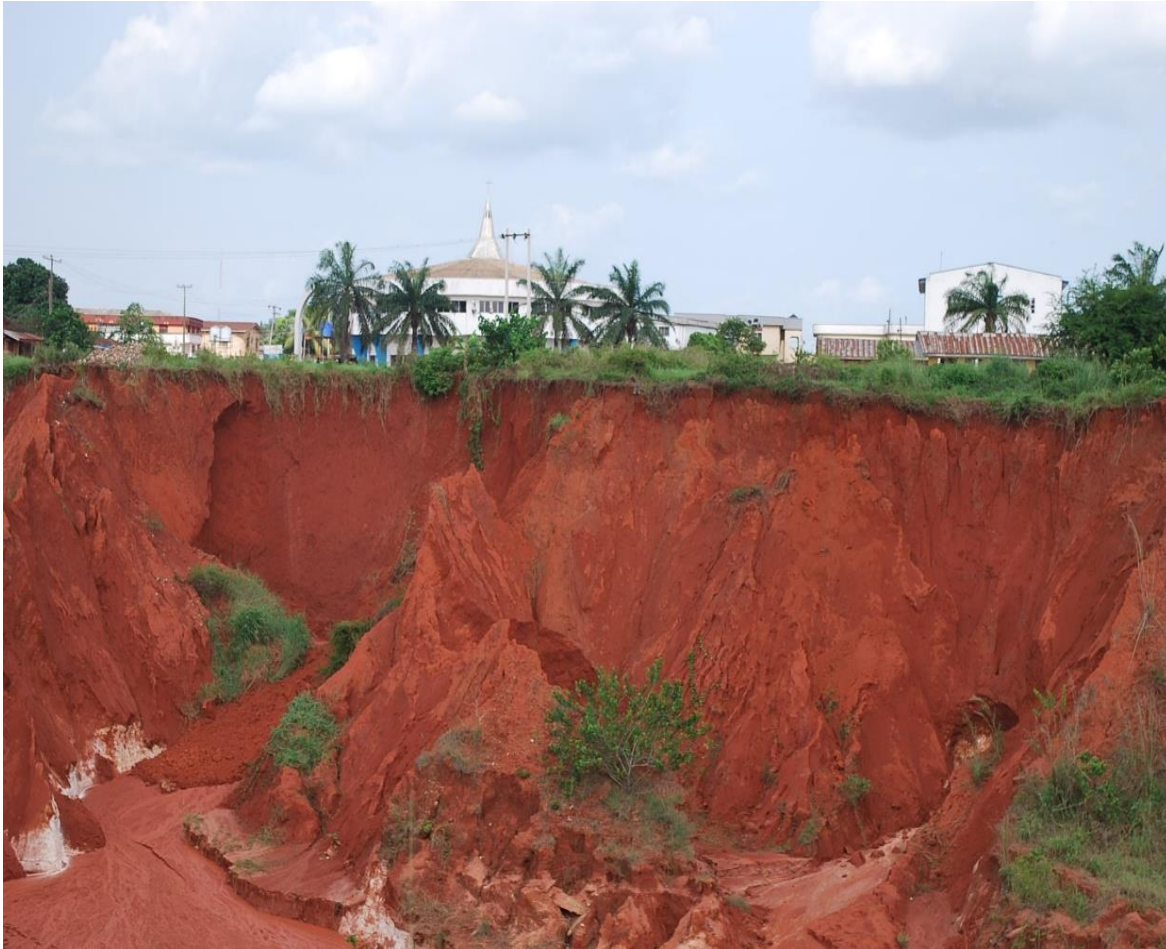
Queen Ede before

Queen Ede Gully Edo State

- Queen Ede gully site, is at Ikpoba Okha Local Government Area of Benin City, Edo State
- The intervention site has estimated gully length of 960 m, maximum depth of about 25 m, average top and base width of about 56 m and 40 m, respectively
- The gully started as a result of abrupt termination of the outlet drain from the Benin-Agbor highway
- Queen Ede site had consumed a couple of houses and destroyed two public schools.
- NEWMAP intervention considered as “a Miracle” by many including Governor Oshiomole of Edo State.
- Intervention solved the severe impacts of flood water along Benin-Agbor highway, Pogah, Edebor, Agbonlahor and Igunbor streets across the road as well as runoff from Aroko estate and Ogbeson village.
- Hundreds of property saved, while interlink roads between the 8 communities restored.

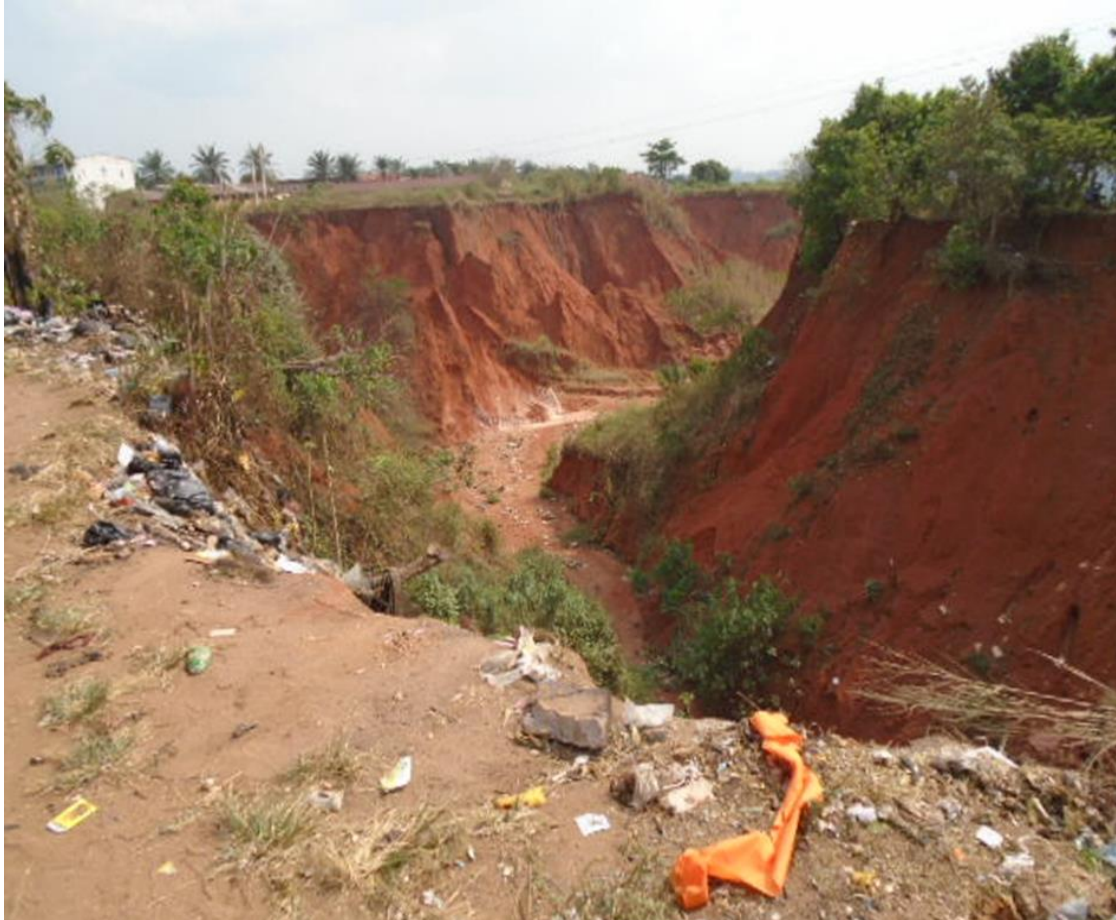
Before

Part of Queen Ede erosion site

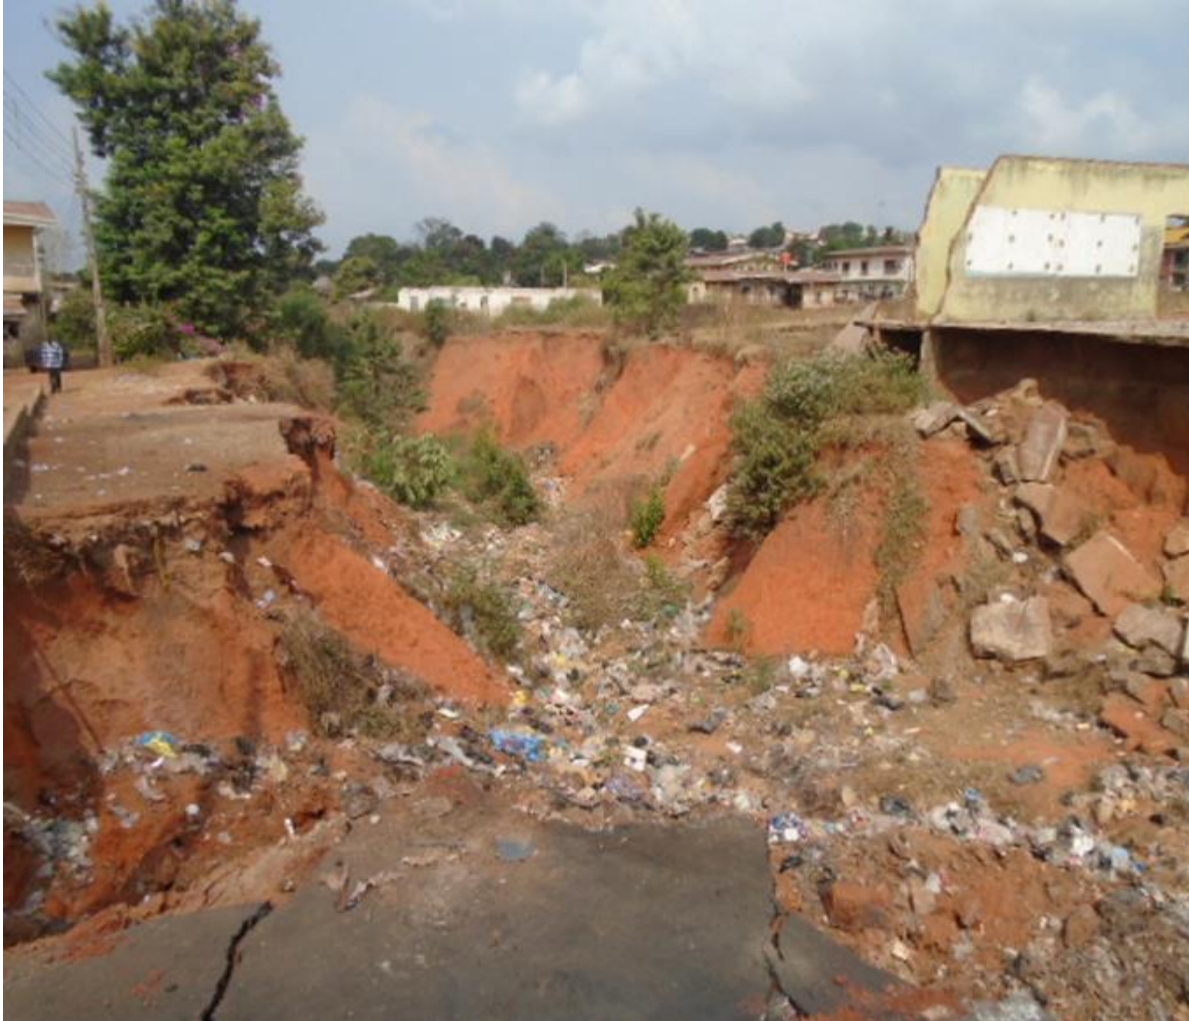
Before in 2013

Auchi Gully Erosion Site

- Auchi is a town located in Etsako West Local Government Area of Edo North, Edo State, Nigeria. Its distance is about 130 km from Benin City, the capital of Edo State, and has an area of 946 km² and a population of about 197,609 (2006 census). **The gully site** is located in an urban area and has damaged several houses. The affected areas includes: Obe Streets, Union Bank road, Hospital roads, Inu Umoru road, Egbe Adokhai, Momoh streets, farm lands, residential buildings, schools, etc. At its deepest, the gully is about 20-25 m.

- **Auchi gully accelerated** in the 1980s when the government engaged in several gully control construction activities within the area in their quest to prevent the action of the gully. In the intervention, most of the drainage systems have insufficient capacity, wrongly placed and in most cases abruptly terminated. All these anthropogenic factors together with the natural factor of convergent topography of Auchi town brought about further destruction and environmental degradation of the gully area.

- **NEWMAP's Intervention** saved over 100 houses that could have been consumed before the check.
- As at April 2015, PAP beneficiaries numbered about 121persons.

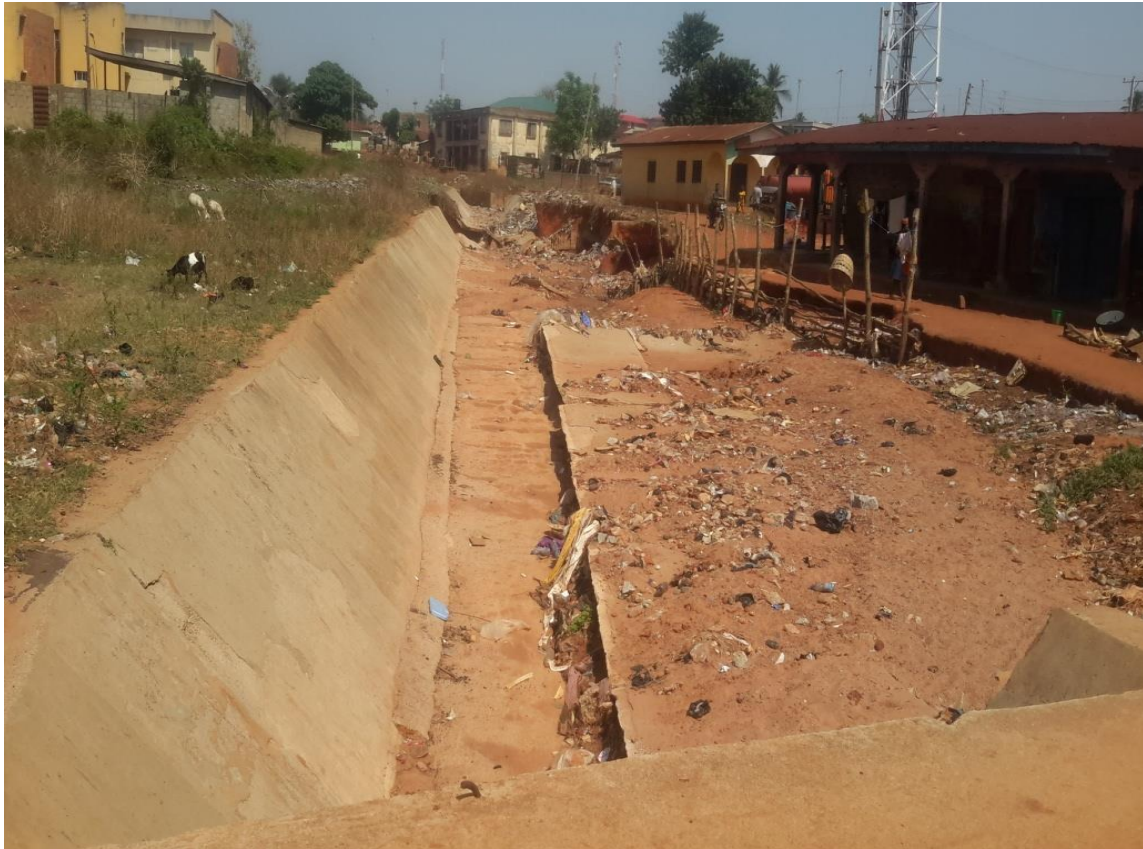
Before

Auchi Gully Erosion Site

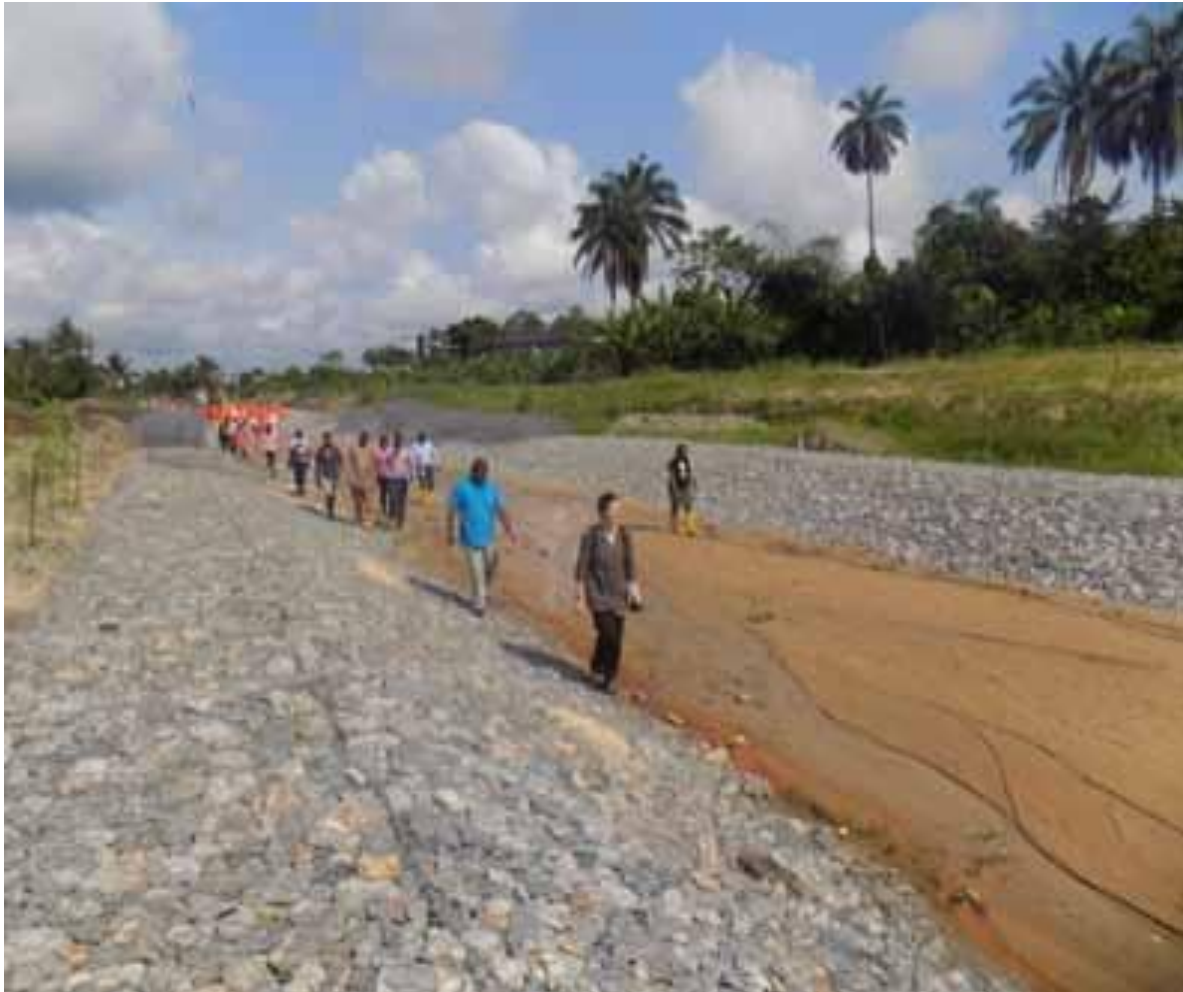
Atakpa in Cross River state

NEWMAP APPROACH FLEXIBLE STRUCTURES
